# Manhole Inspection Summary

Manhole # S31I1015MH

**Location** Address: **305 TUSCANY RD**

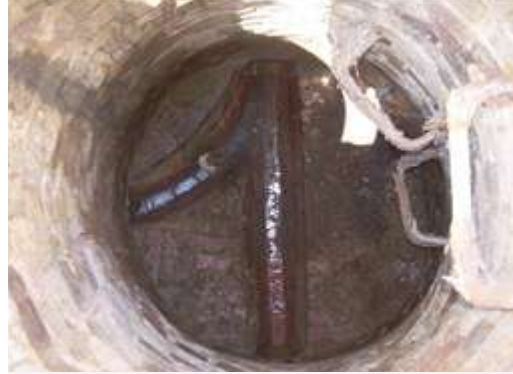
Top View

Corroded steps, bench debris

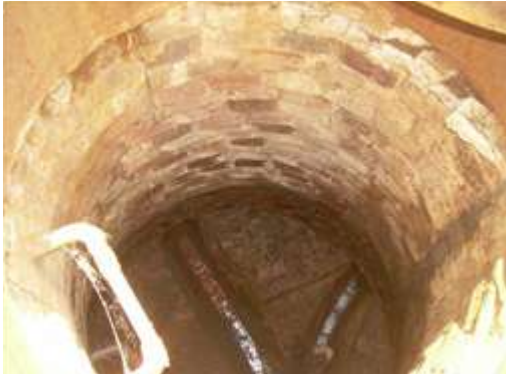
Defect

Frame leaks. Adjustment deterioration, loose brick and infiltration. Barrel infiltration.

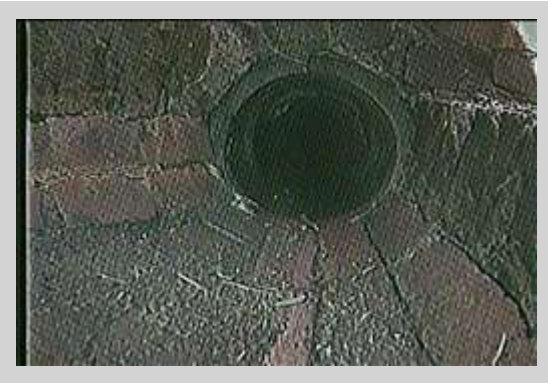
### 8 in. Circular Gravity Sewer Pipe Out @ 12 O'Clock

Channel deterioration.

Infiltration: **Evidence** Pipe Seal Cond: **Cracked**

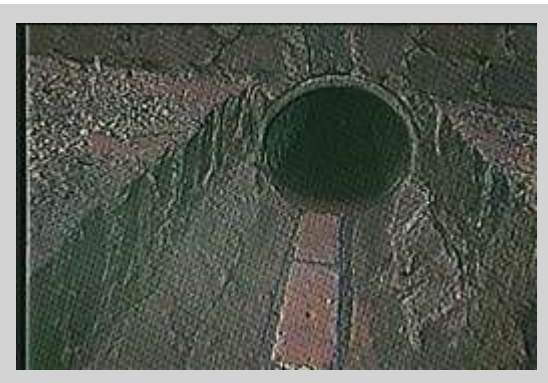
### 8 in. Circular Gravity Sewer Pipe In @ 6 O'Clock

Infiltration: **Evidence** Pipe Seal Cond: **Cracked**

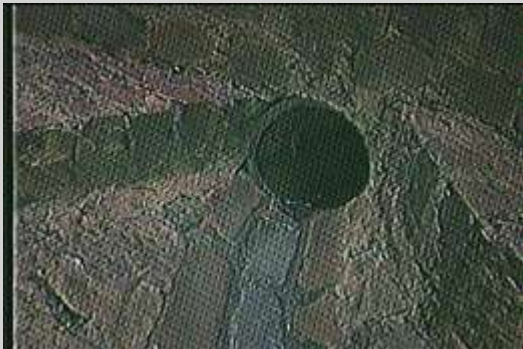
6 in. Circular Gravity Sewer  
Pipe In @ 9 O'Clock

Infiltration: **Evidence** Pipe Seal Cond: **Cracked**
